**Flood Control Project Maintenance
Levee Inspections**

Maintenance Issue Types Only, Levee Inspection Report By Mile - Spring 2017

Reclamation District No. 0404 Boggs

Waterway	Bank	Unit Miles	Inspection Start/End	Inspector
Unit No. 01 San Joaquin River	Right	2.35	04/06/2017 04/06/2017	Richard Willoughby

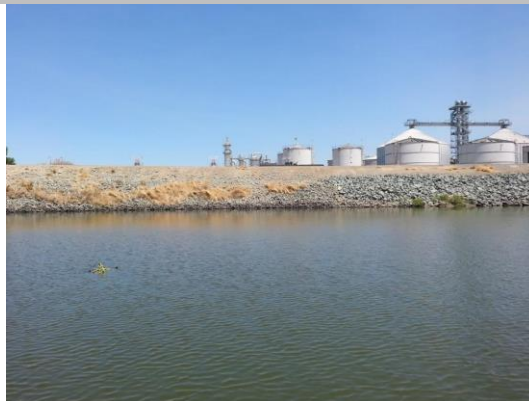
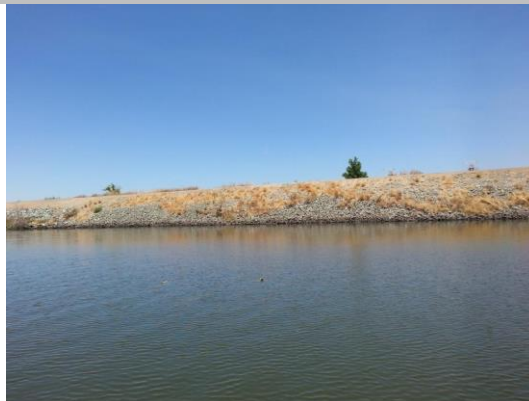
Photo 1 of 2 : SP_2017_RD0404_305_32_20170316_00021.jpg

LM Start	0.34	Rating **	U	Issue No.	32
LM End	0.34	Issue Type +	Ma	Location *	WS
Category	Supplemental			GPS Latitude/Longitude	
				Start	End
Item	DWR Erosion Survey			37.939190°	37.939190°
				-121.338280°	-121.338280°
DWR ID	DWR_RD0404_01_s_2017_32				
Comment Code					
Inspector Comment					
07/25/2016: No significant change observed.					
06/24/2015: No significant change observed.					
06/19/2014: No significant change observed.					
08/13/2013: No significant change at this site.					
08/7/2012: The erosion is next to a repaired site and approximately 400 feet downstream of a river bend. There are broken concretes at the upper levee slope, but not visible at the levee toe or lower slope. Likely the protection concrete blocks have been washed away. [2016 Site ID:RD0404U01RM41.11]

Front view of the site.

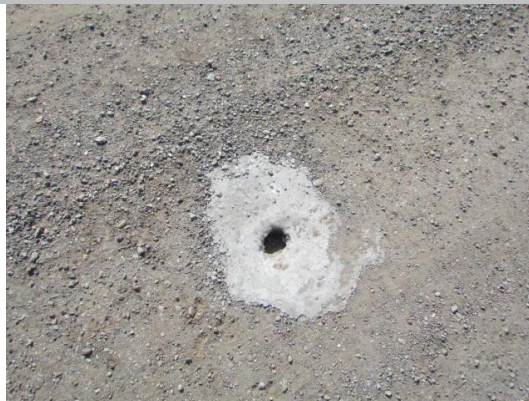
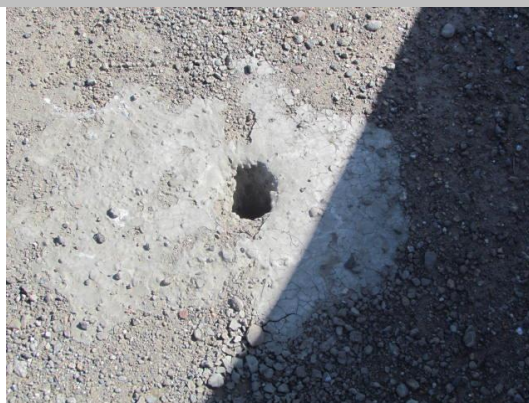
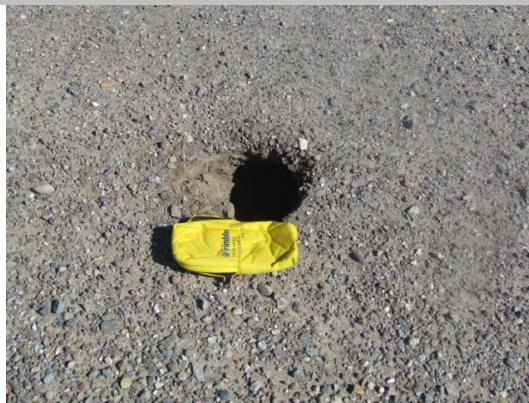
Photo 1 of 4 : SP_2017_RD0404_305_5_20170316_00004.jpg

LM Start	0.43	Rating **	A/W	Issue No.	5
LM End	0.43	Issue Type +	Ma	Location *	CR
Category	Earthen Levee			GPS Latitude/Longitude	
				Start	End
Item	Animal Control			37.939635 °	37.939635 °
				-121.339063 °	-121.339063 °
DWR ID	DWR_RD0404_01_s_2013_5				
Comment Code					
A3 : No rodents visible, but rodent burrows visible; need to backfill and compact or grout burrows.					
Inspector Comment					
District grouted hole, and the deficiency still exist.

Looking at partialled grouted rodent hole on levee crown (Fall 2014).

Looking at partially grouted rodent hole on levee crown

Looking at rodent hole on levee crown.

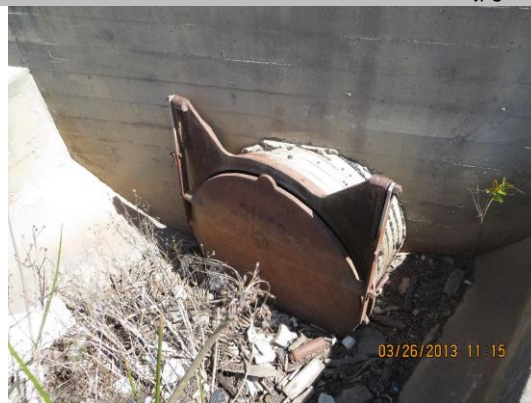
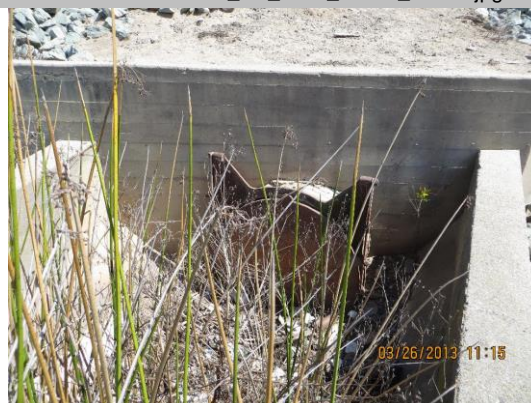
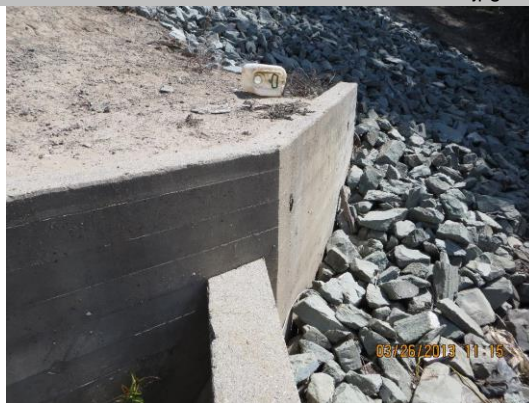
Photo 1 of 3 : UCIP_SP_2017_51169_19962.jpg

FS_ID:51169
DS_ID:17945
EP_NO: N/A
Repair Type: Urgent
Crossing Status: Found
UCIP Comments: 11/29/2016 Flap gate still buried with sediment on WS. Requires clearing. (K. Fazel - UCIP)03/26/2013 Partially buried flap gate (P. Amatya - DWR)
FIELD_STRUCT_DESC: 42-inch corrugated metal drainage pipe, 18 feet below the crown. Flap gate, concrete headwall and spillway on the waterside (WS). Pumphouse on the landside (LS). Abandoned concrete headwall, power pole, and two wooden piles found on the LS.
[Additional Reference(s): DWR Levee Log, 2006. USACE San Joaquin O&M Manual 001, March 1963 (HLM 0.78)]. Pipe likely belongs to the City of Stockton.
FS Date: 11/29/2016

WS- drainage outlet structure and CM pipe with flapgate

WS- Debris and vegetation blocking CM drainage pipe

WS- slightly tilted outlet structure

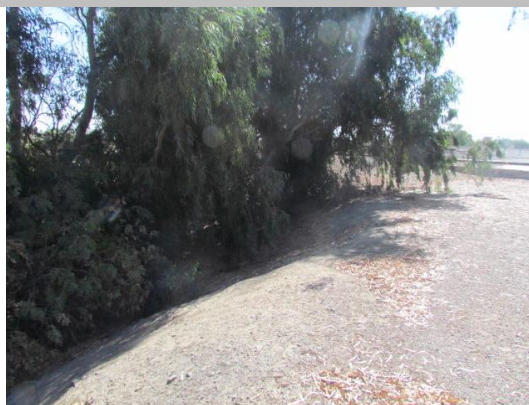
Photo 1 of 1 : SP_2017_RD0404_305_8_20170316_00009.jpg

LM Start	0.78	Rating **	M	Issue No.	8
LM End	0.78	Issue Type +	Ma	Location *	LS
Category	Earthen Levee			GPS Latitude/Longitude	
				Start	End
Item	Trim / Thin Trees			37.937395 °	37.937395 °
				-121.333883 °	-121.333883 °
DWR ID	DWR_RD0404_01_s_2013_8				
Comment Code					
T1 : Trim trees to at least five feet above ground level.					
Inspector Comment					
Trees are blocking view of the slope.

Looking southeast at dense trees on landward slope and toe.

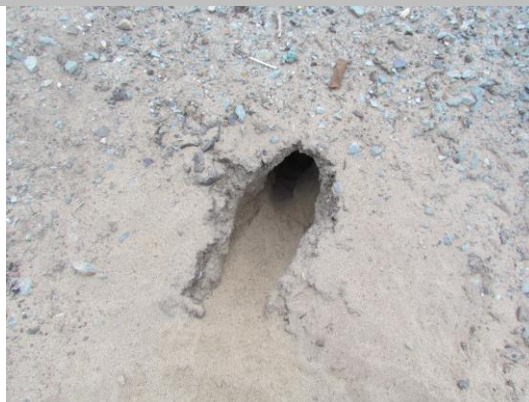
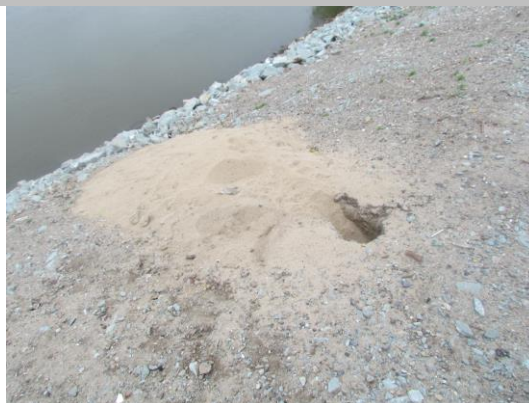
Photo 1 of 2 : SP_2017_RD0404_305_42_20170407_00070.jpg

Looking west at large animal hole (den) on waterward shoulder.

Looking northwest at large animal hole (den) on waterward shoulder.

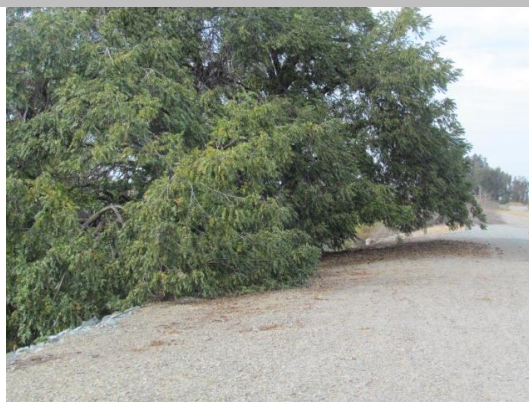
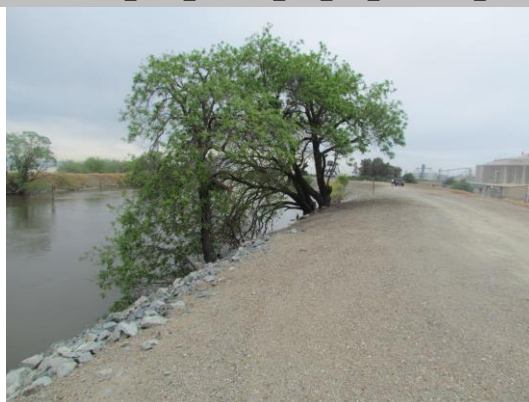
Photo 1 of 2 : SP_2017_RD0404_305_102_20170316_00032.jpg

LM Start	1.07	Rating **	A/W	Issue No.	102
LM End	1.07	Issue Type +	Ma	Location *	WS
Category	Earthen Levee			GPS Latitude/Longitude	
				Start	End
Item	Trim / Thin Trees			37.935358 °	37.935358 °
				-121.329645 °	-121.329645 °
DWR ID	DWR_RD0404_01_s_2012_102				
Comment Code					
T1 : Trim trees to at least five feet above ground level.					
Inspector Comment					
LMA corrected issue.

Looking northwest at untrimmed tree on waterward slope.

Looking northwest at trimmed tree on waterward slope. (Spring 2017)

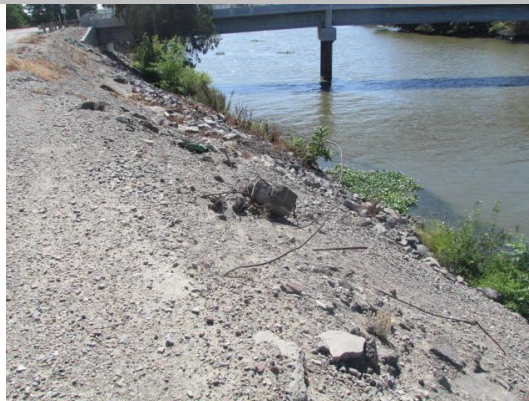
Photo 1 of 1 : SP_2017_RD0404_305_4_20170316_00003.jpg

Looking southwest at concrete rubble with rebar on waterward slope.

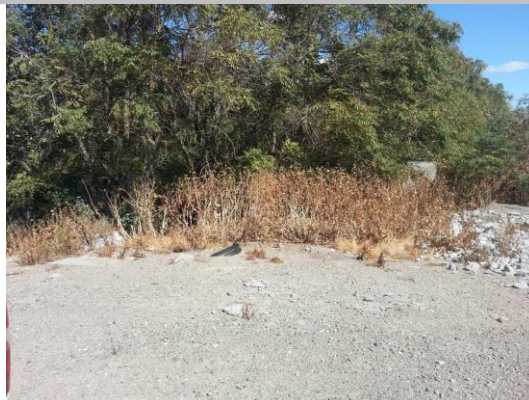
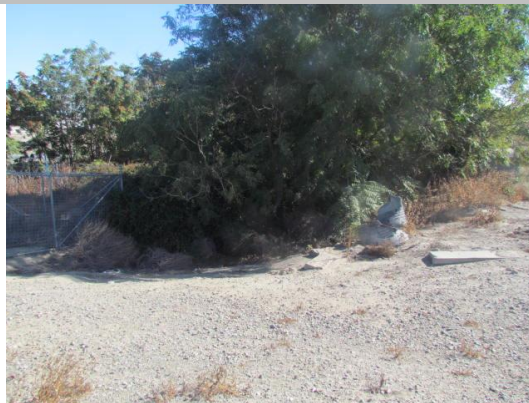
Photo 1 of 2 : SP_2017_RD0404_305_101_20170316_00030.jpg

Looking east at dense vegetation on landward slope. (Fall 2016)

Looking southeast at overhanging trees on landside slope. (Fall 2015)

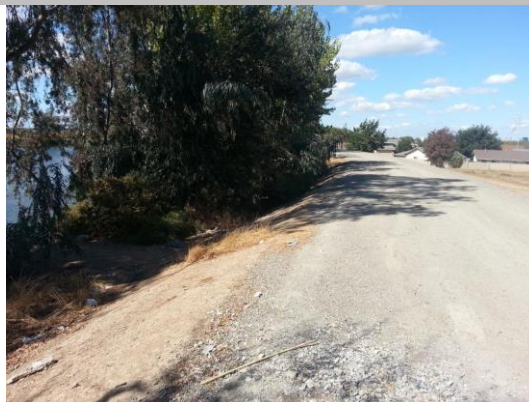
Photo 1 of 1 : SP_2017_RD0404_305_100_20170316_00029.jpg

LM Start	1.35	Rating **	U	Issue No.	100
LM End	1.35	Issue Type +	Ma	Location *	WS
Category	Earthen Levee			GPS Latitude/Longitude	
				Start	End
Item	Trim / Thin Trees			37.931945 °	37.931945 °
				-121.327150 °	-121.327150 °
DWR ID	DWR_RD0404_01_s_2012_100				
Comment Code					
T1 : Trim trees to at least five feet above ground level.					
Inspector Comment

Looking northwest at untrimmed trees on waterward slope.

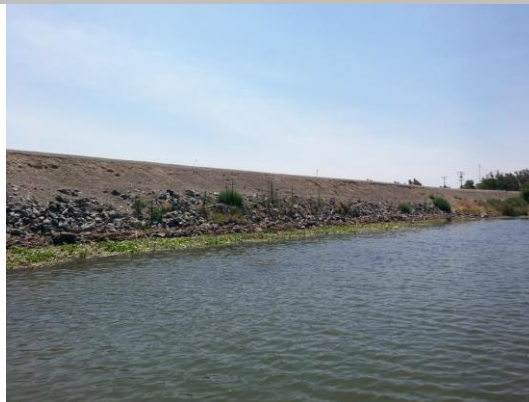
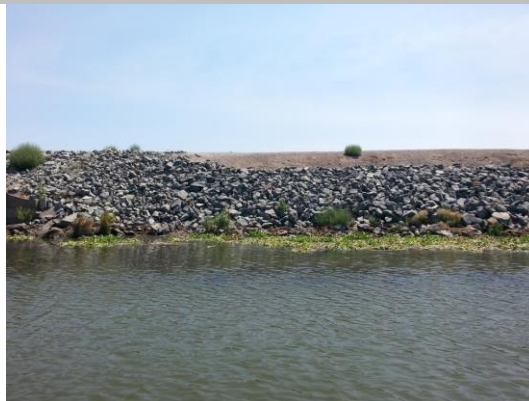
Photo 1 of 2 : SP_2017_RD0404_305_41_20170316_00027.jpg

LM Start	1.44	Rating **	M	Issue No.	41
LM End	1.46	Issue Type +	Ma	Location *	WS
Category	Supplemental			GPS Latitude/Longitude	
				Start	End
Item	DWR Erosion Survey			37.930450 °	37.930450 °
				-121.327450 °	-121.327450 °
DWR ID	DWR_RD0404_01_s_2017_41				
Comment Code					
Inspector Comment					
07/25/2016: No significant change observed.					
06/24/2015: No significant change observed.					
06/19/2014: A series of scarp erosions have been found on the lower levee slope and at the levee toe. [2016 Site ID:RD0404U01RM42.02]

Downstream view of the erosion.

Close view of the erosion. The upstream end of the site is protected by riprap revetment.

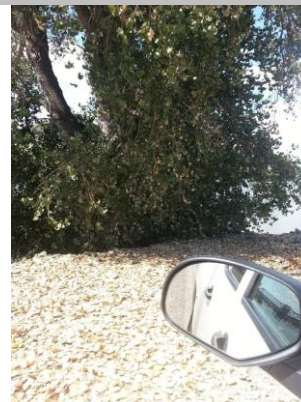
Photo 1 of 1 : SP_2017_RD0404_305_27_20170316_00015.jpg

LM Start	1.50	Rating **	A/W	Issue No.	27
LM End	1.50	Issue Type +	Ma	Location *	WS
Category	Earthen Levee			GPS Latitude/Longitude	
				Start	End
Item	Trim / Thin Trees			37.896544 °	37.896544 °
				-121.327121 °	-121.327121 °
DWR ID	DWR_RD0404_01_f_2016_27				
Comment Code					
T2 : Thin trees to allow visibility of the ground and room to flood fight.					
Inspector Comment

Looking west at untrimmed trees on waterward slope.

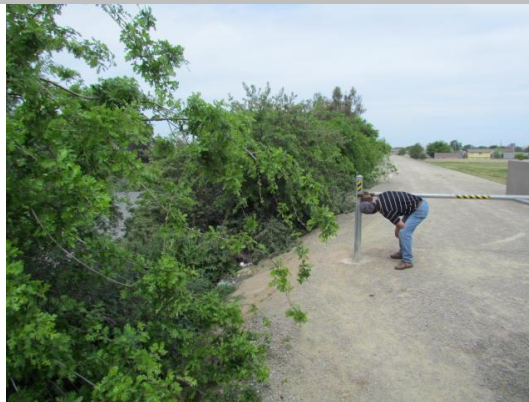
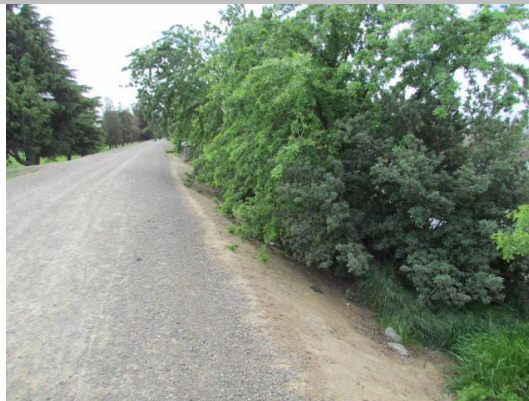
Photo 1 of 2 : SP_2017_RD0404_305_29_20170316_00018.jpg

Looking north at dense vegetation on waterward slope.

Looking south at dense vegetation on waterward slope.

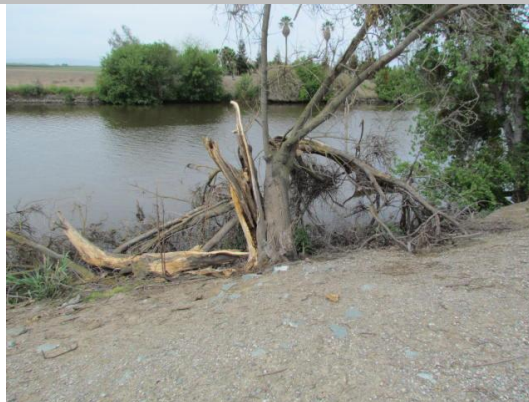
Photo 1 of 1 : SP_2017_RD0404_305_33_20170316_00023.jpg

Looking west at dead tree on waterward slope.

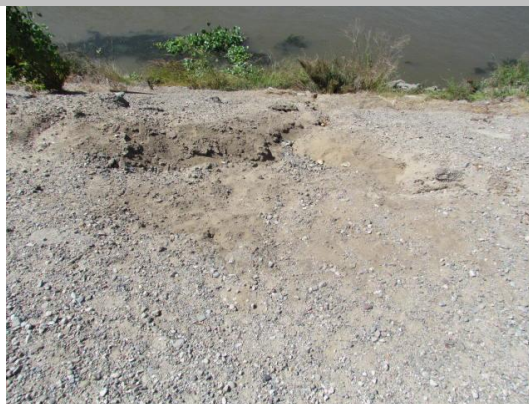
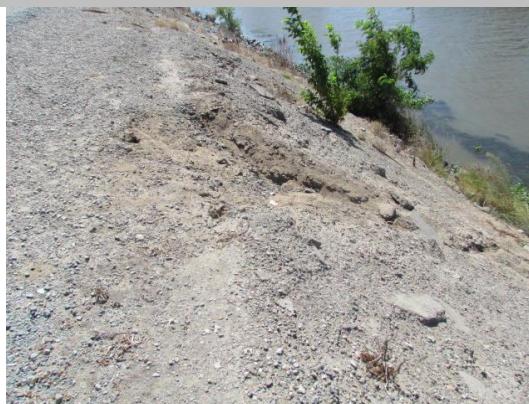
Photo 1 of 2 : SP_2017_RD0404_305_16_20170316_00011.jpg

LM Start	2.01	Rating **	M	Issue No.	16
LM End	2.01	Issue Type +	Ma	Location *	WS
Category	Earthen Levee			GPS Latitude/Longitude	
				Start	End
Item	Slope Stability			37.923470 °	37.923470 °
				-121.322978 °	-121.322978 °
DWR ID	DWR_RD0404_01_f_2013_16				
Comment Code					
S2 : Repair the levee slope damaged by foot traffic and prevent access where possible.					
Inspector Comment					
Slope damage due to foot traffic.

Looking west at slope damage due to foot traffic.

Looking southwest at slope damage due to foot traffic.

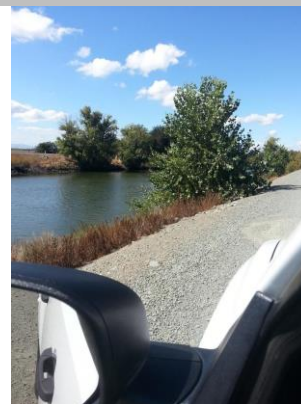
Photo 1 of 1 : SP_2017_RD0404_305_13_20170316_00010.jpg

LM Start	2.08	Rating **	A/W	Issue No.	13
LM End	2.08	Issue Type +	Ma	Location *	WS
Category	Earthen Levee			GPS Latitude/Longitude	
				Start	End
Item	Trim / Thin Trees			37.922669 °	37.922669 °
				-121.322272 °	-121.322272 °
DWR ID	DWR_RD0404_01_f_2012_13				
Comment Code					
T1 : Trim trees to at least five feet above ground level.					
Inspector Comment

Looking northwest at untrimmed tree on waterward slope.

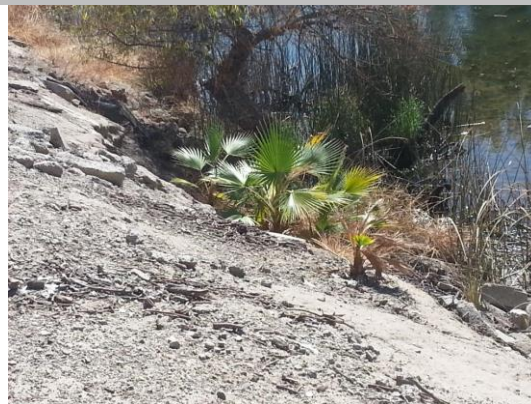
Photo 1 of 1 : SP_2017_RD0404_306_14_20170316_00003.jpg

LM Start	0.14	Rating **	U	Issue No.	14
LM End	0.14	Issue Type +	Ma	Location *	WS
Category	Earthen Levee			GPS Latitude/Longitude	
				Start	End
Item	Erosion / Bank Caving			37.918875 °	37.918875 °
				-121.316587 °	-121.316587 °
DWR ID	DWR_RD0404_02_f_2016_14				
Comment Code					
E2 : Schedule repair of erosion site prior to the next inspection.					
Inspector Comment

Looking southeast at erosion on waterward slope.

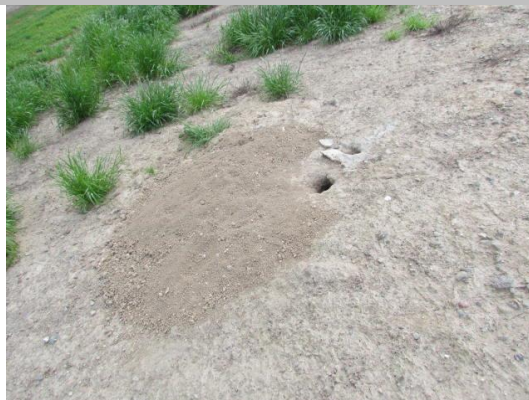
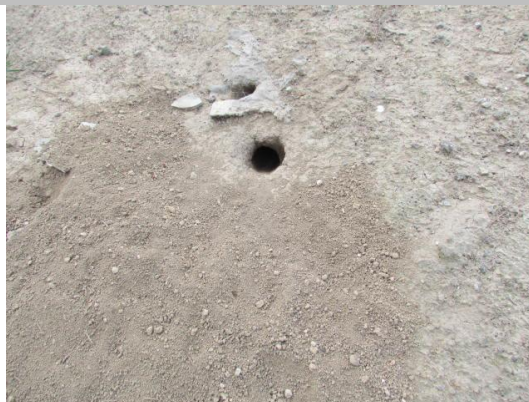
Photo 1 of 2 : SP_2017_RD0404_306_21_20170316_00009.jpg

LM Start	0.68	Rating **	U	Issue No.	21
LM End	0.94	Issue Type +	Ma	Location *	LS
Category	Earthen Levee			GPS Latitude/Longitude	
				Start	End
Item	Animal Control			37.919245 °	37.916652 °
				-121.307705 °	-121.305085 °
DWR ID	DWR_RD0404_02_s_2016_21				
Comment Code					
A1 : Exterminate rodents and backfill and compact or grout burrows.					
Inspector Comment					
Large holes noted on landward slope.

Looking northeast at large roden hole on landward slope.

Looking east at large rodent hole on landward slope.

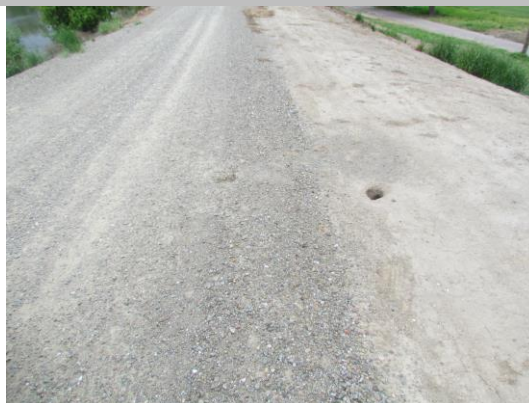
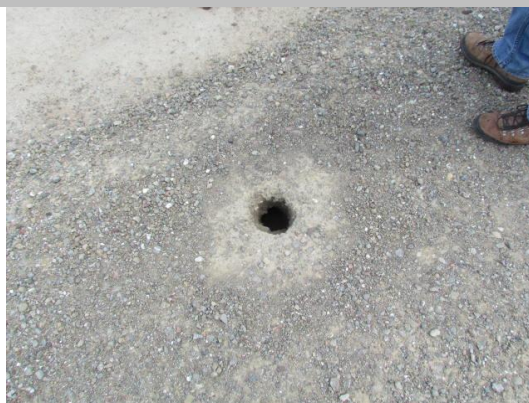
Photo 1 of 3 : SP_2017_RD0404_306_20_20170407_00031.jpg

Looking northeast at rodent hole on landward shoulder.

Looking at rodent hole on levee crown.

Looking at rodent hole on landward slope.

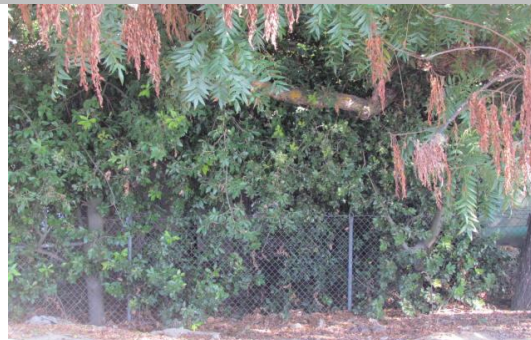
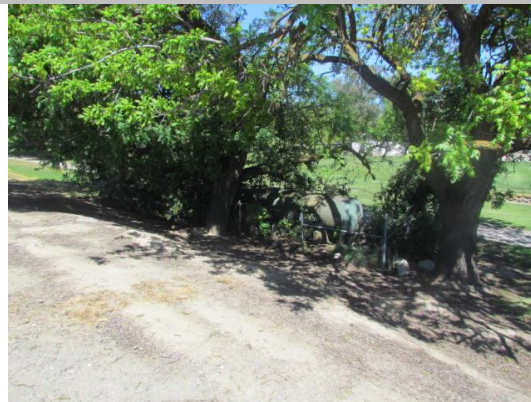
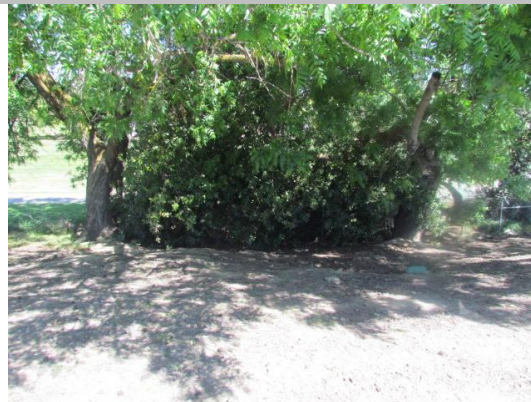
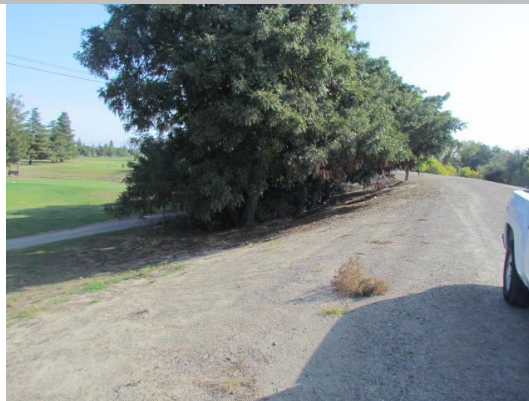
Photo 1 of 4 : SP_2017_RD0404_306_67_20170316_00011.jpg

Looking northeast at dense vegetation inside fenced area near pump station on landside toe.

Looking north at dense vegetation on landward toe around propane tank.

Looking northeast at dense vegetation on landward toe. (Spring 2013)

Looking east at dense vegetation near pump station on landside toe.

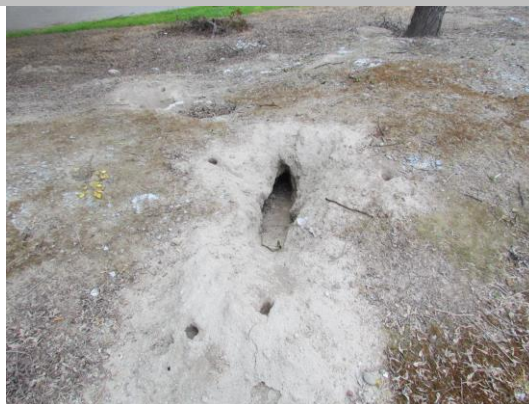
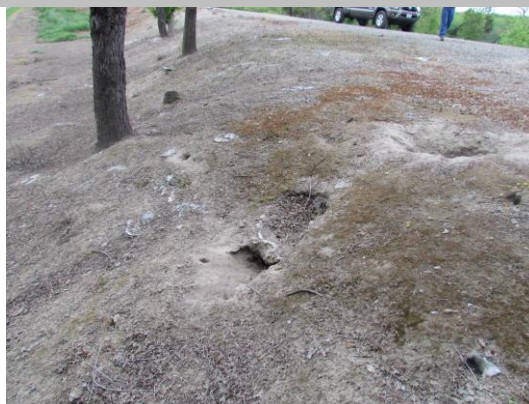
Photo 1 of 2 : SP_2017_RD0404_306_22_20170407_00032.jpg

Looking east at large rodent hole on landward slope.

Looking southwest at several rodent holes on landward slope.

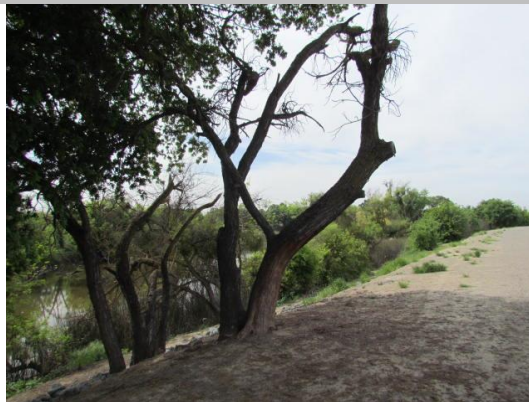
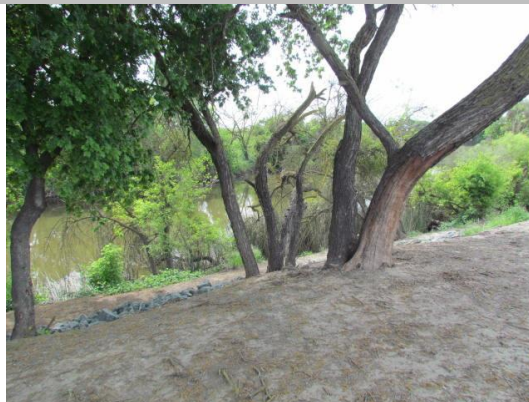
Photo 1 of 2 : SP_2017_RD0404_306_18_20170316_00005.jpg

Looking east at dead trees on waterward slope.

Looking at close up view of dead trees on waterward slope.

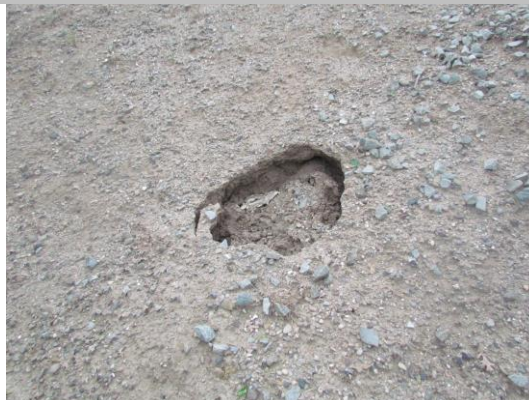
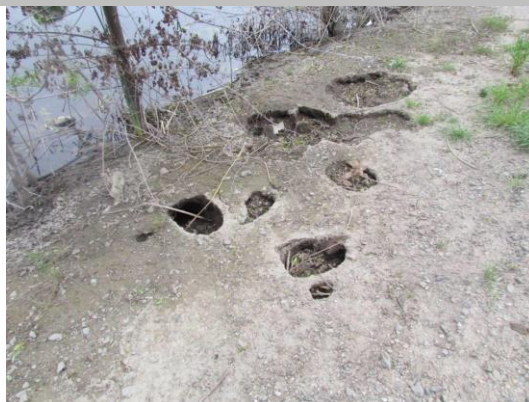
Photo 1 of 2 : SP_2017_RD0404_306_19_20170407_00034.jpg

LM Start	1.65	Rating **	U	Issue No.	19
LM End	1.65	Issue Type +	Ma	Location *	WS
Category	Earthen Levee			GPS Latitude/Longitude	
				Start	End
Item	Erosion / Bank Caving			37.917860 °	37.917860 °
				-121.293530 °	-121.293530 °
DWR ID	DWR_RD0404_02_s_2017_19				
Comment Code					
E2 : Schedule repair of erosion site prior to the next inspection.					
Inspector Comment					
Several sinkholes near toe of levee

Looking north at one of several sink holes at waterward toe.

Looking north at several sink holes at waterward toe.
